City of Santa Barbara
Planning Division

Memorandum

SUBJECT: **Staff Evaluation of additions and alterations to a City Landmark, the San Marcos Building as it applies to the Historic Resource Design Guidelines.**

ADDRESS: 1124-31 State Street and 9 West Anapamu Street, San Marcos Building

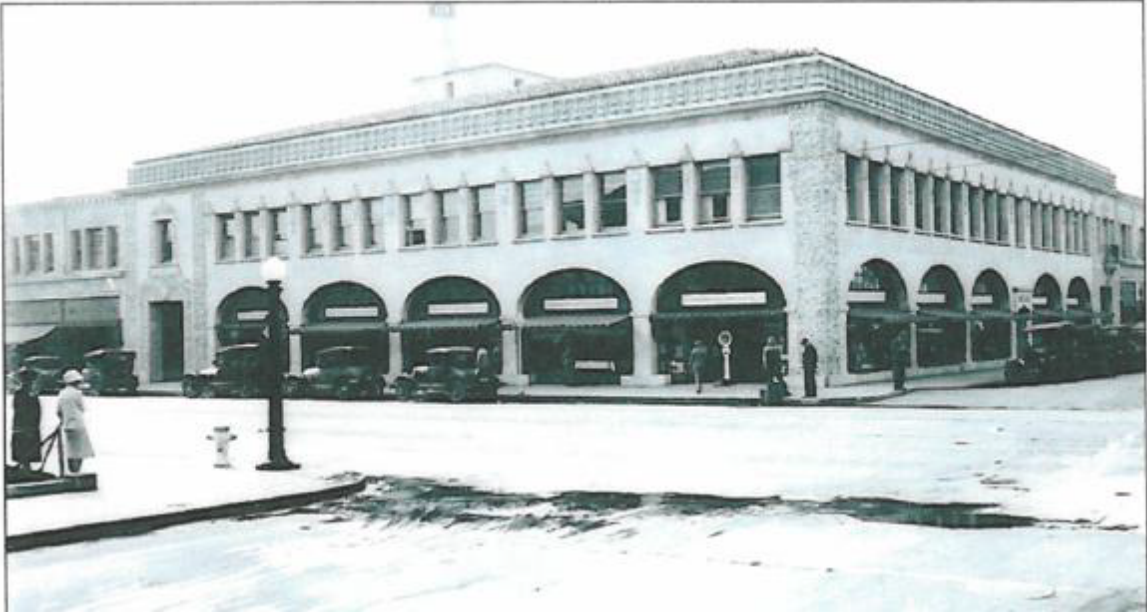
*#1 Above: San Marcos Building after 1926 reconstruction.
Robert Easton Collection, Santa Barbara Public Library*

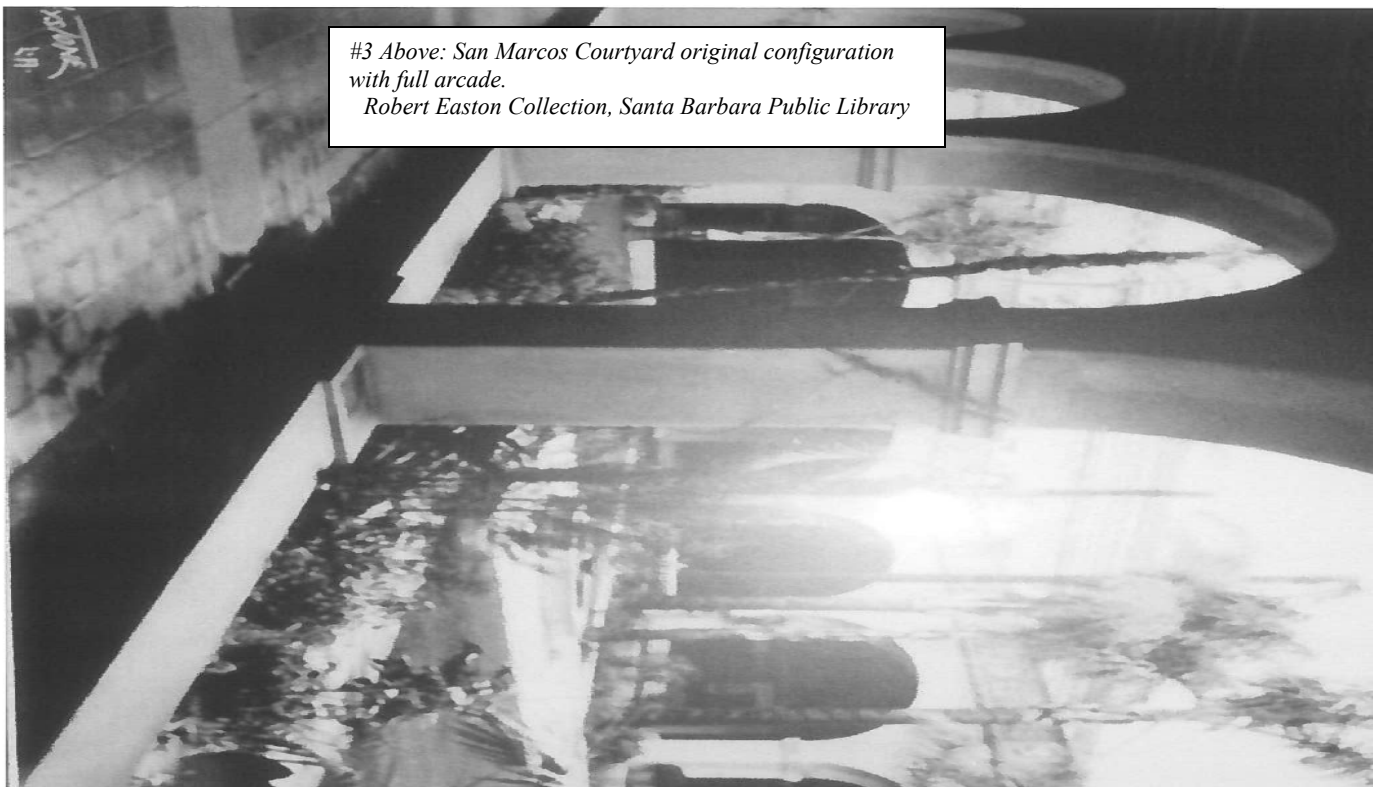
#3 Above: San Marcos Courtyard original configuration
with full arcade.
Robert Easton Collection, Santa Barbara Public Library

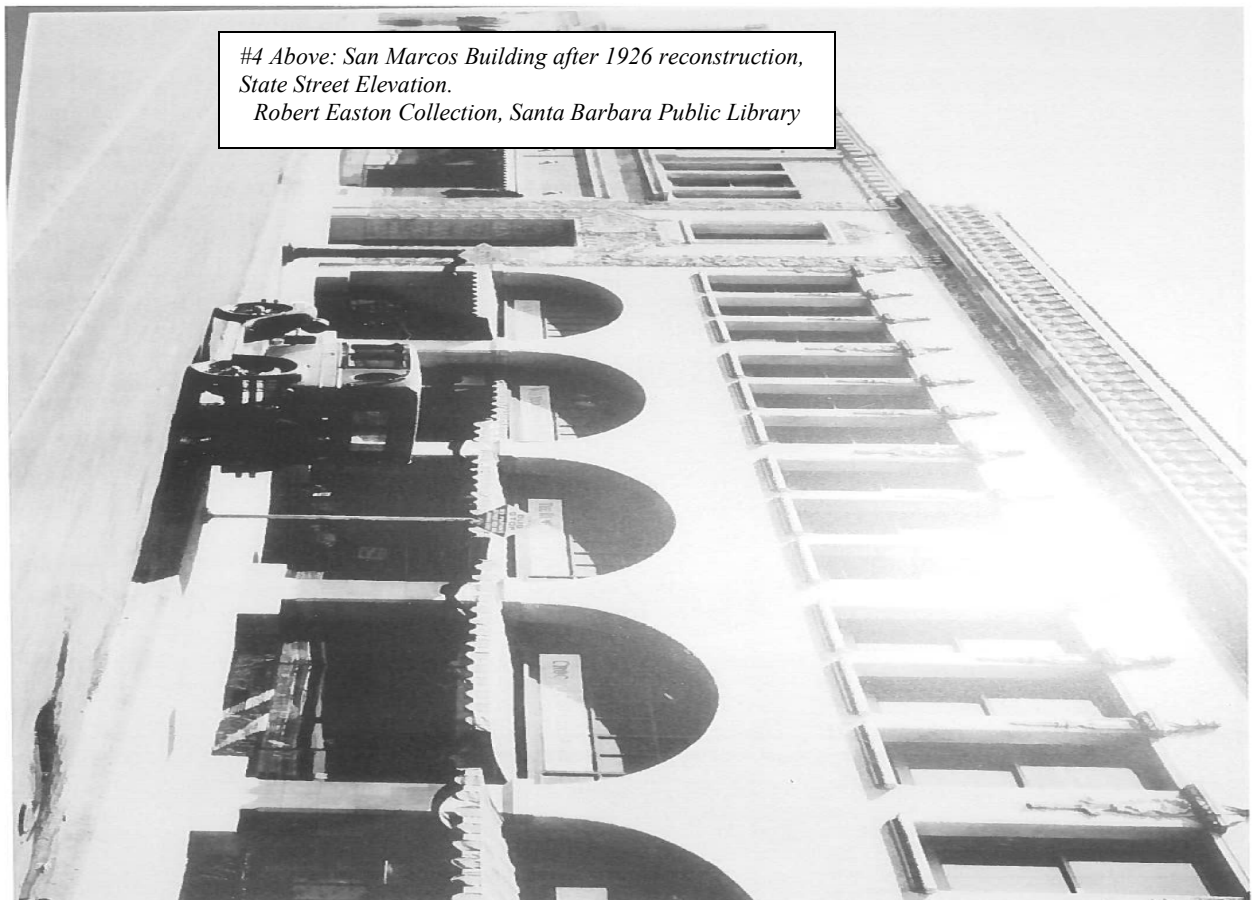
*#4 Above: San Marcos Building after 1926 reconstruction,
State Street Elevation.
Robert Easton Collection, Santa Barbara Public Library*

Discussion: The four other round bay transom windows on State Street were all filled with stucco. Originally, the round bay transoms all had divided lights and the storefront at the face of the building recessed just behind the columns dividing the bays. Based on the photographic evidence provided in this report, the proposal to bring the existing storefront forward will return the bay to its original configuration. However in order for the Commission to make the required finding, the storefront should be recessed just behind the column and the transom design should match the original with more divided lights.

The Urban Historian recommends the State Street storefront match the original configuration behind the columns that divide the bay and with divided lights in the transom to match the original as provided by photographic evidence. The State Street elevation is the most visible elevation of the City Landmark and the Commission is required to make the following finding per SBMC# 22.22.070, "The exterior alterations are being made primarily for the purposes of restoring the Landmark to its original appearance or in order to substantially aid in the preservation or enhancement of the Landmark." The other alterations 2-4 proposed will enhance the use of the San Marcos building and meet the Secretary of Interior Standard Number 9.

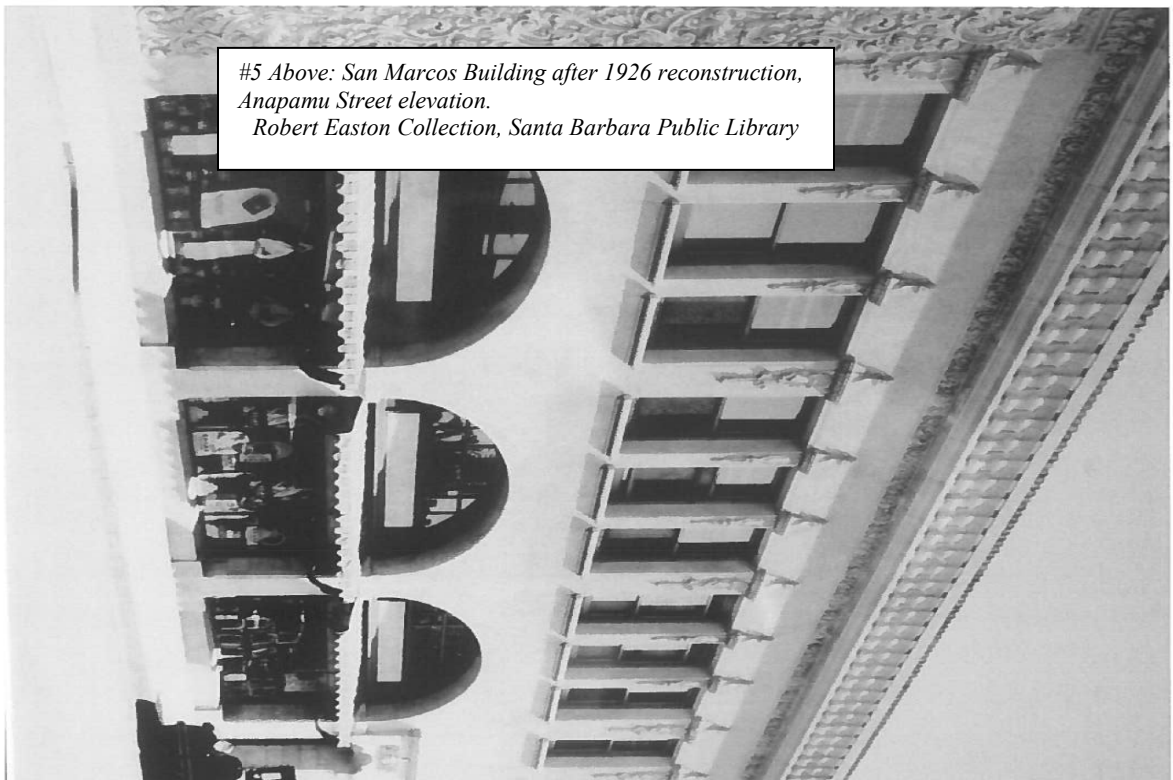
#5 Above: *San Marcos Building after 1926 reconstruction,
Anapamu Street elevation.*
Robert Easton Collection, Santa Barbara Public Library

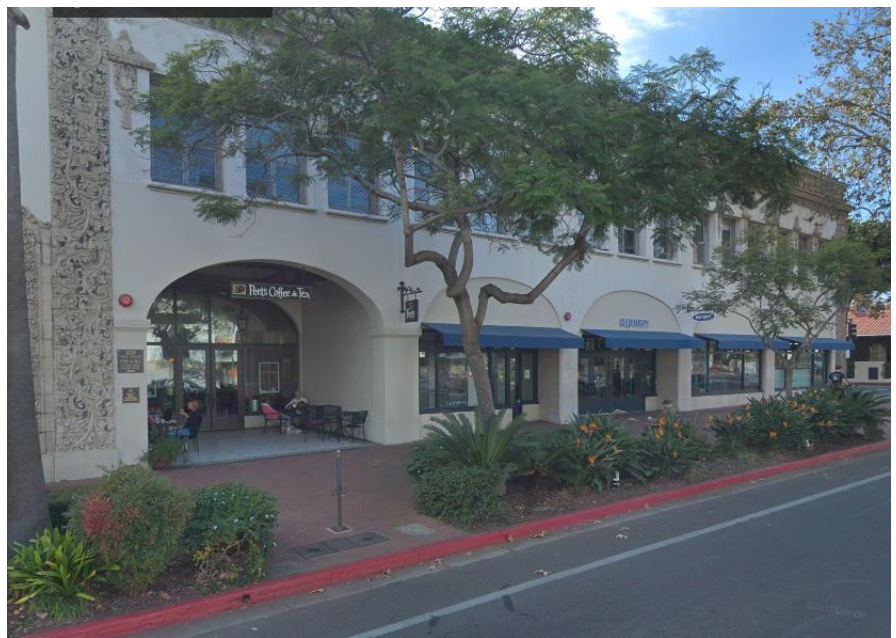
Above: San Marcos Building State Street Storefronts in existing condition.

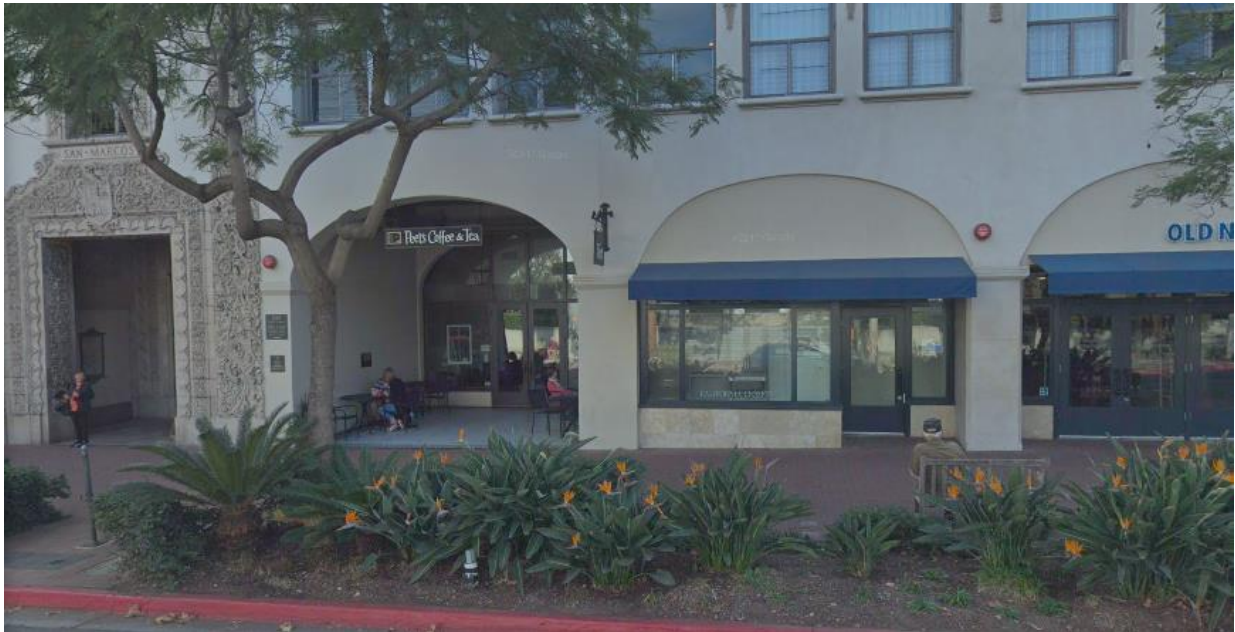
2. Paseo #1: Proposal to add entry storefronts leading into 1131 State Street and 1124 State Street

Applicable Secretary of Interior Standard #9: New additions, exterior alterations, or related new construction will not destroy historic materials, features, and spatial relationships that characterize the property. The new work will be differentiated from the old and will be compatible with the historic materials, features, size, scale and proportion, and massing to protect the integrity of the property and its environment.
